① BUREAU OF SHIPS GROUP
TECHNICAL INSPECTION REPORT

(6) OPERATION CROSSROADS.

FAILURES OF MASTS, YARDARMS,
BOOMS AND RIGGING [U.]

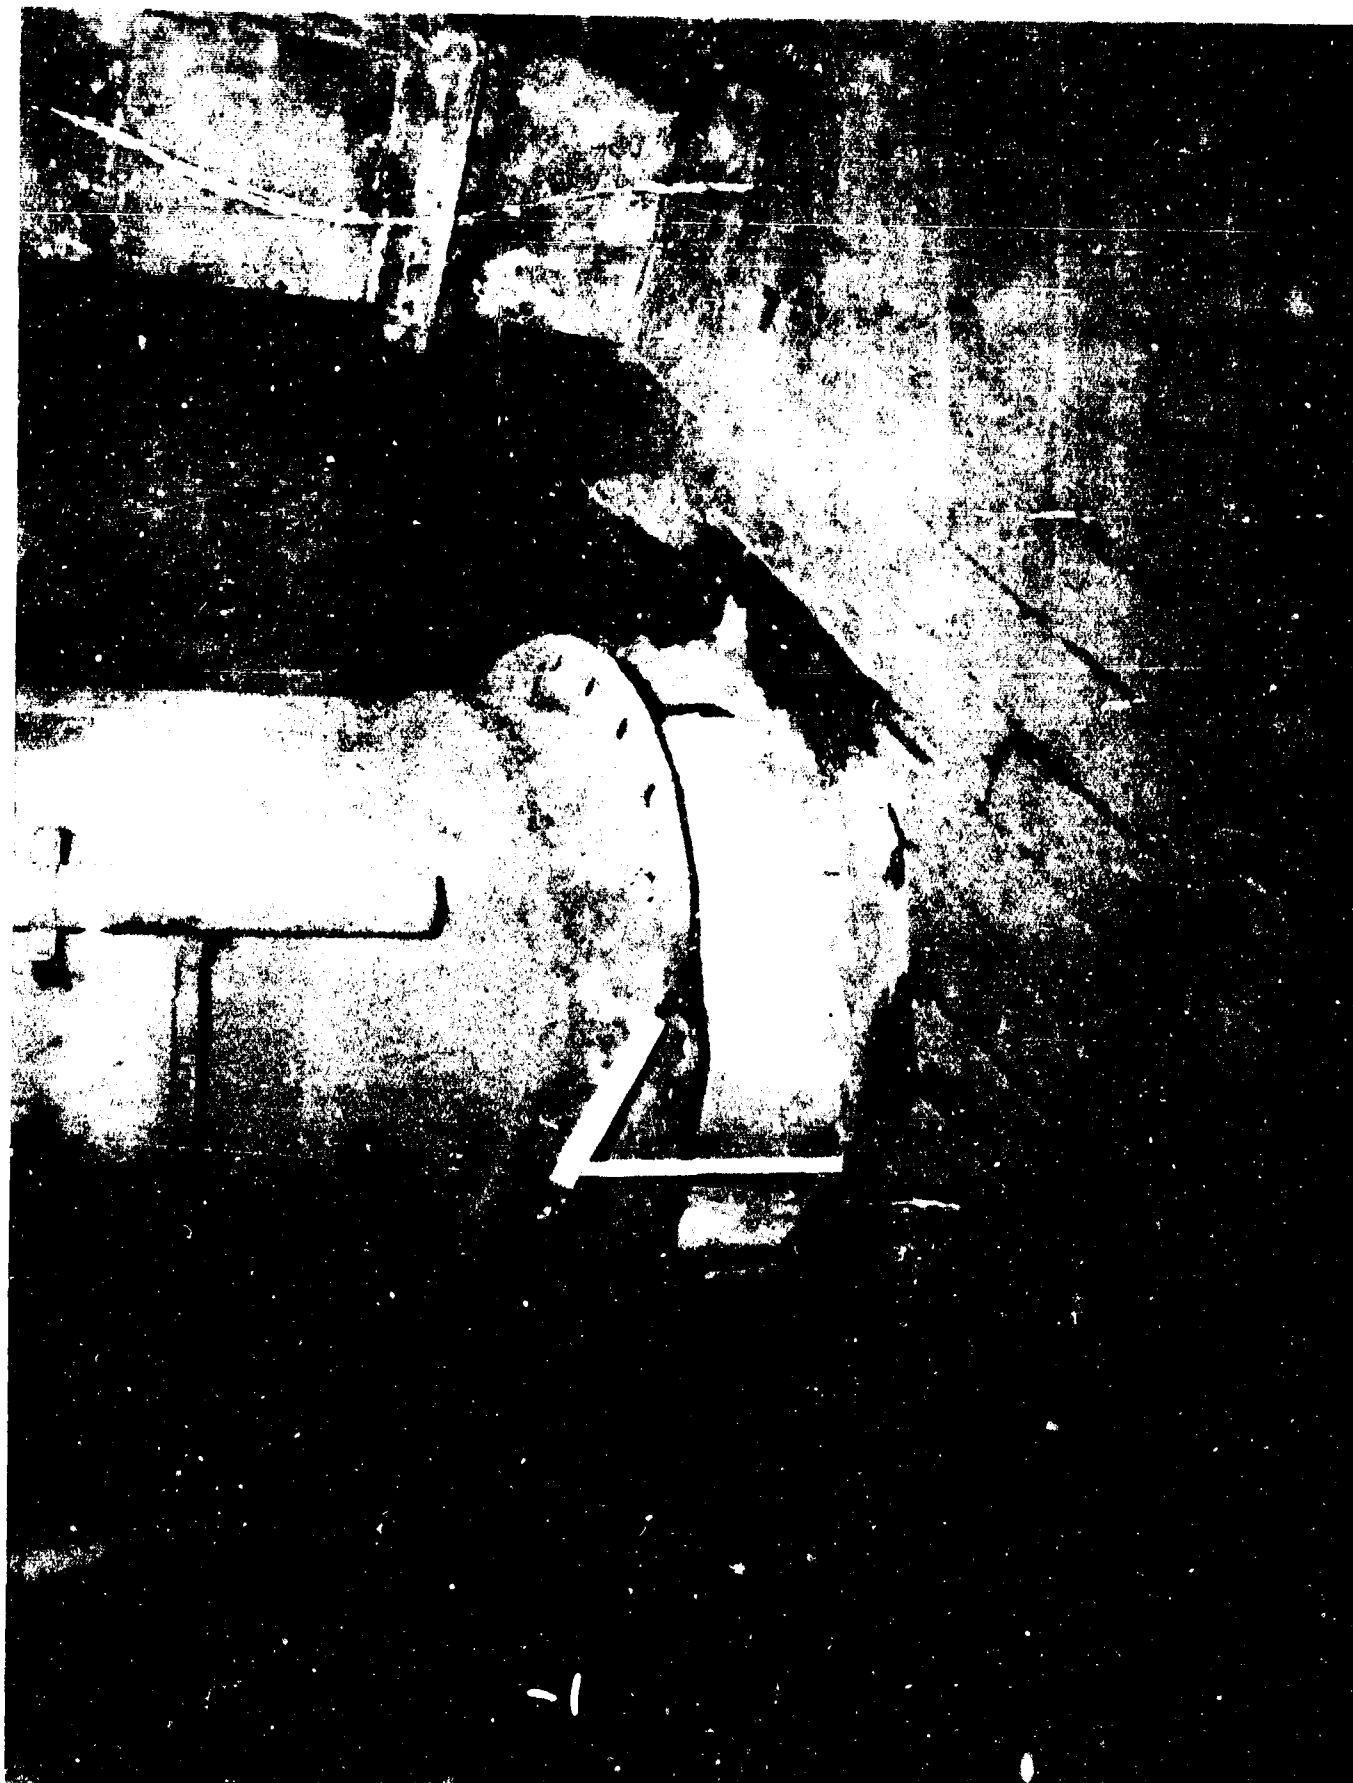
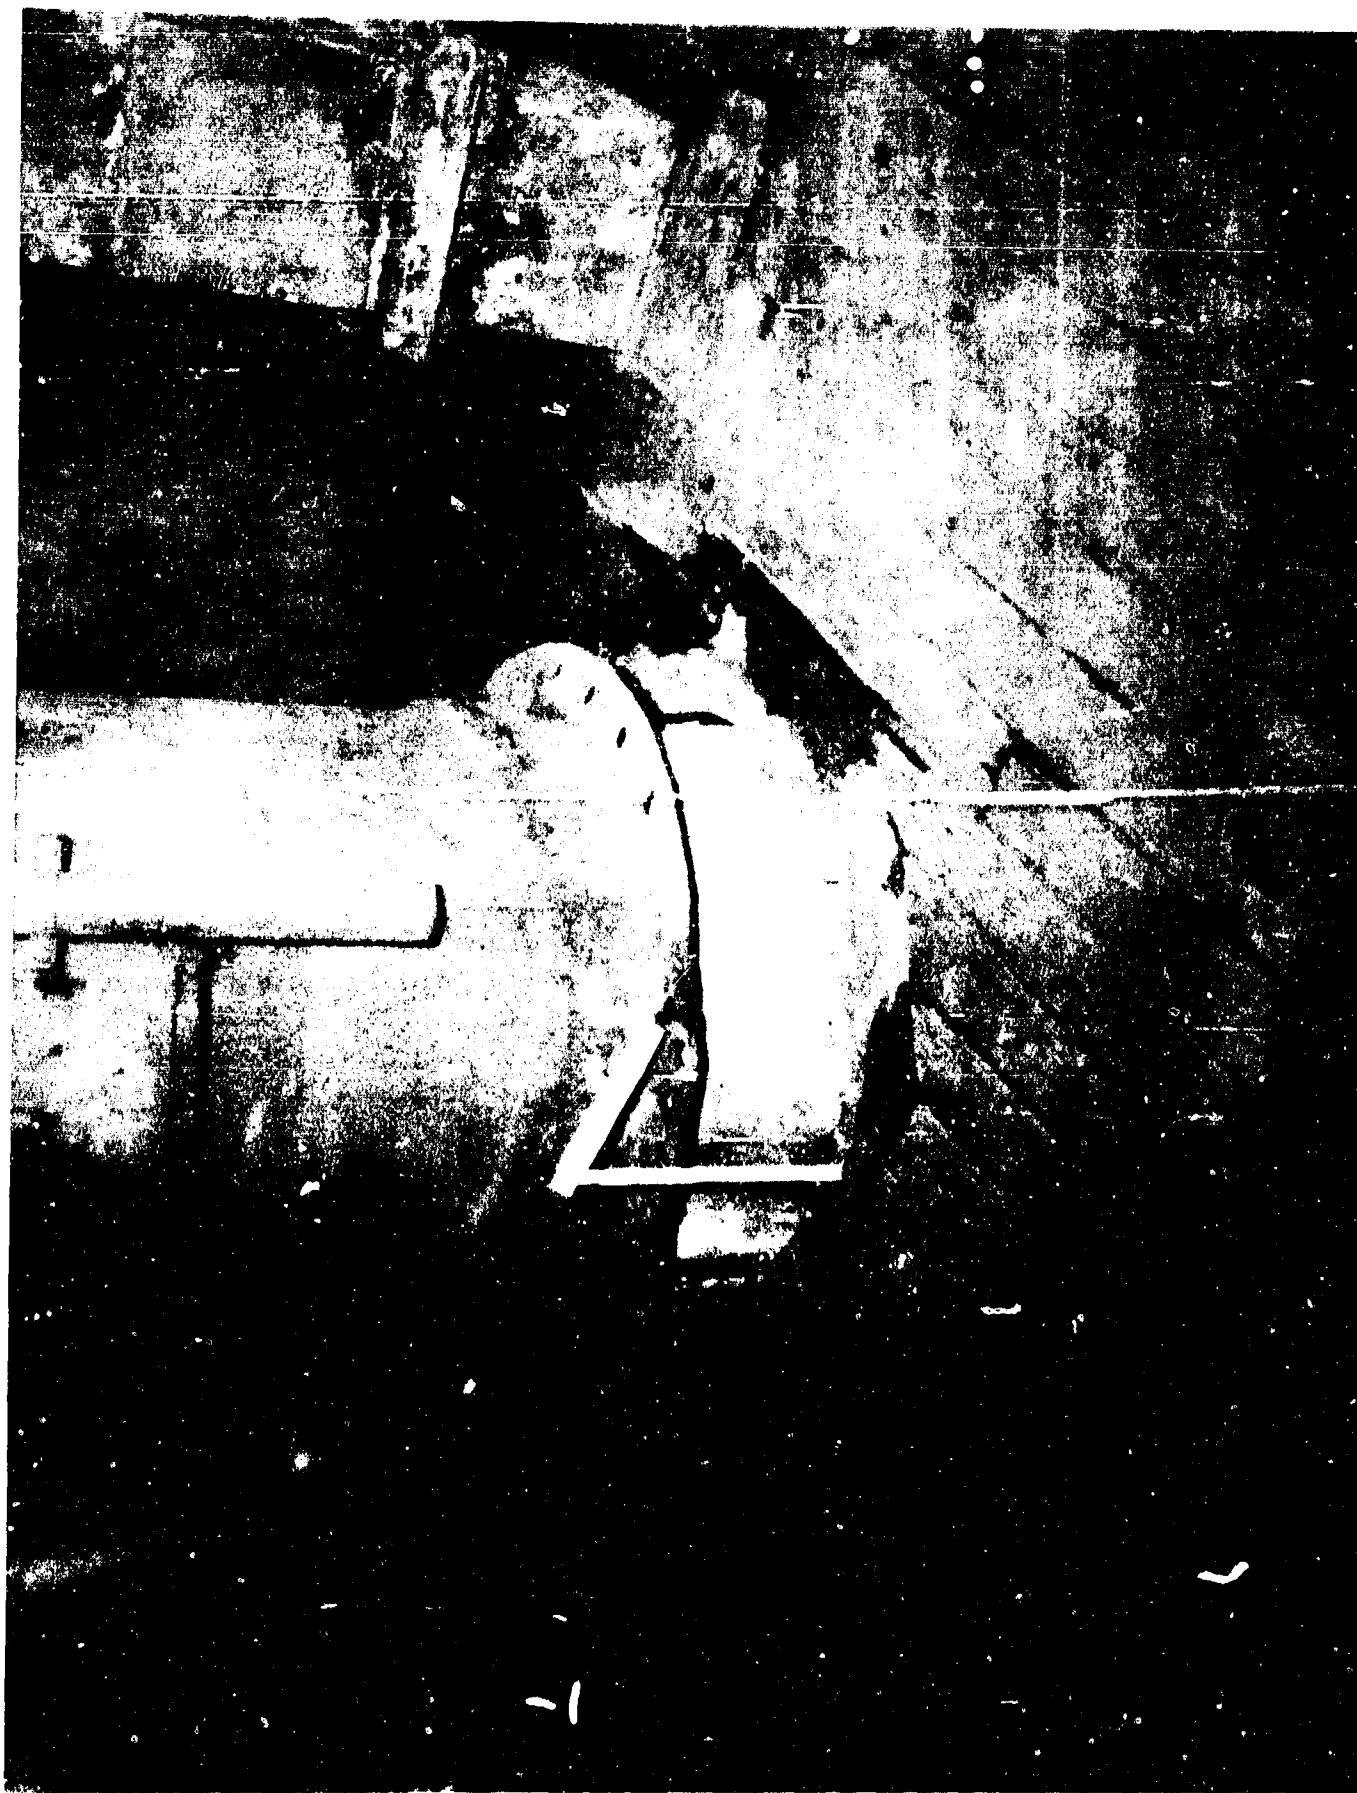
AA-CR-68-2146-1. USS ARKANSAS (BB33). Mainmast, starboard aft leg, showing lift from deck, main deck.

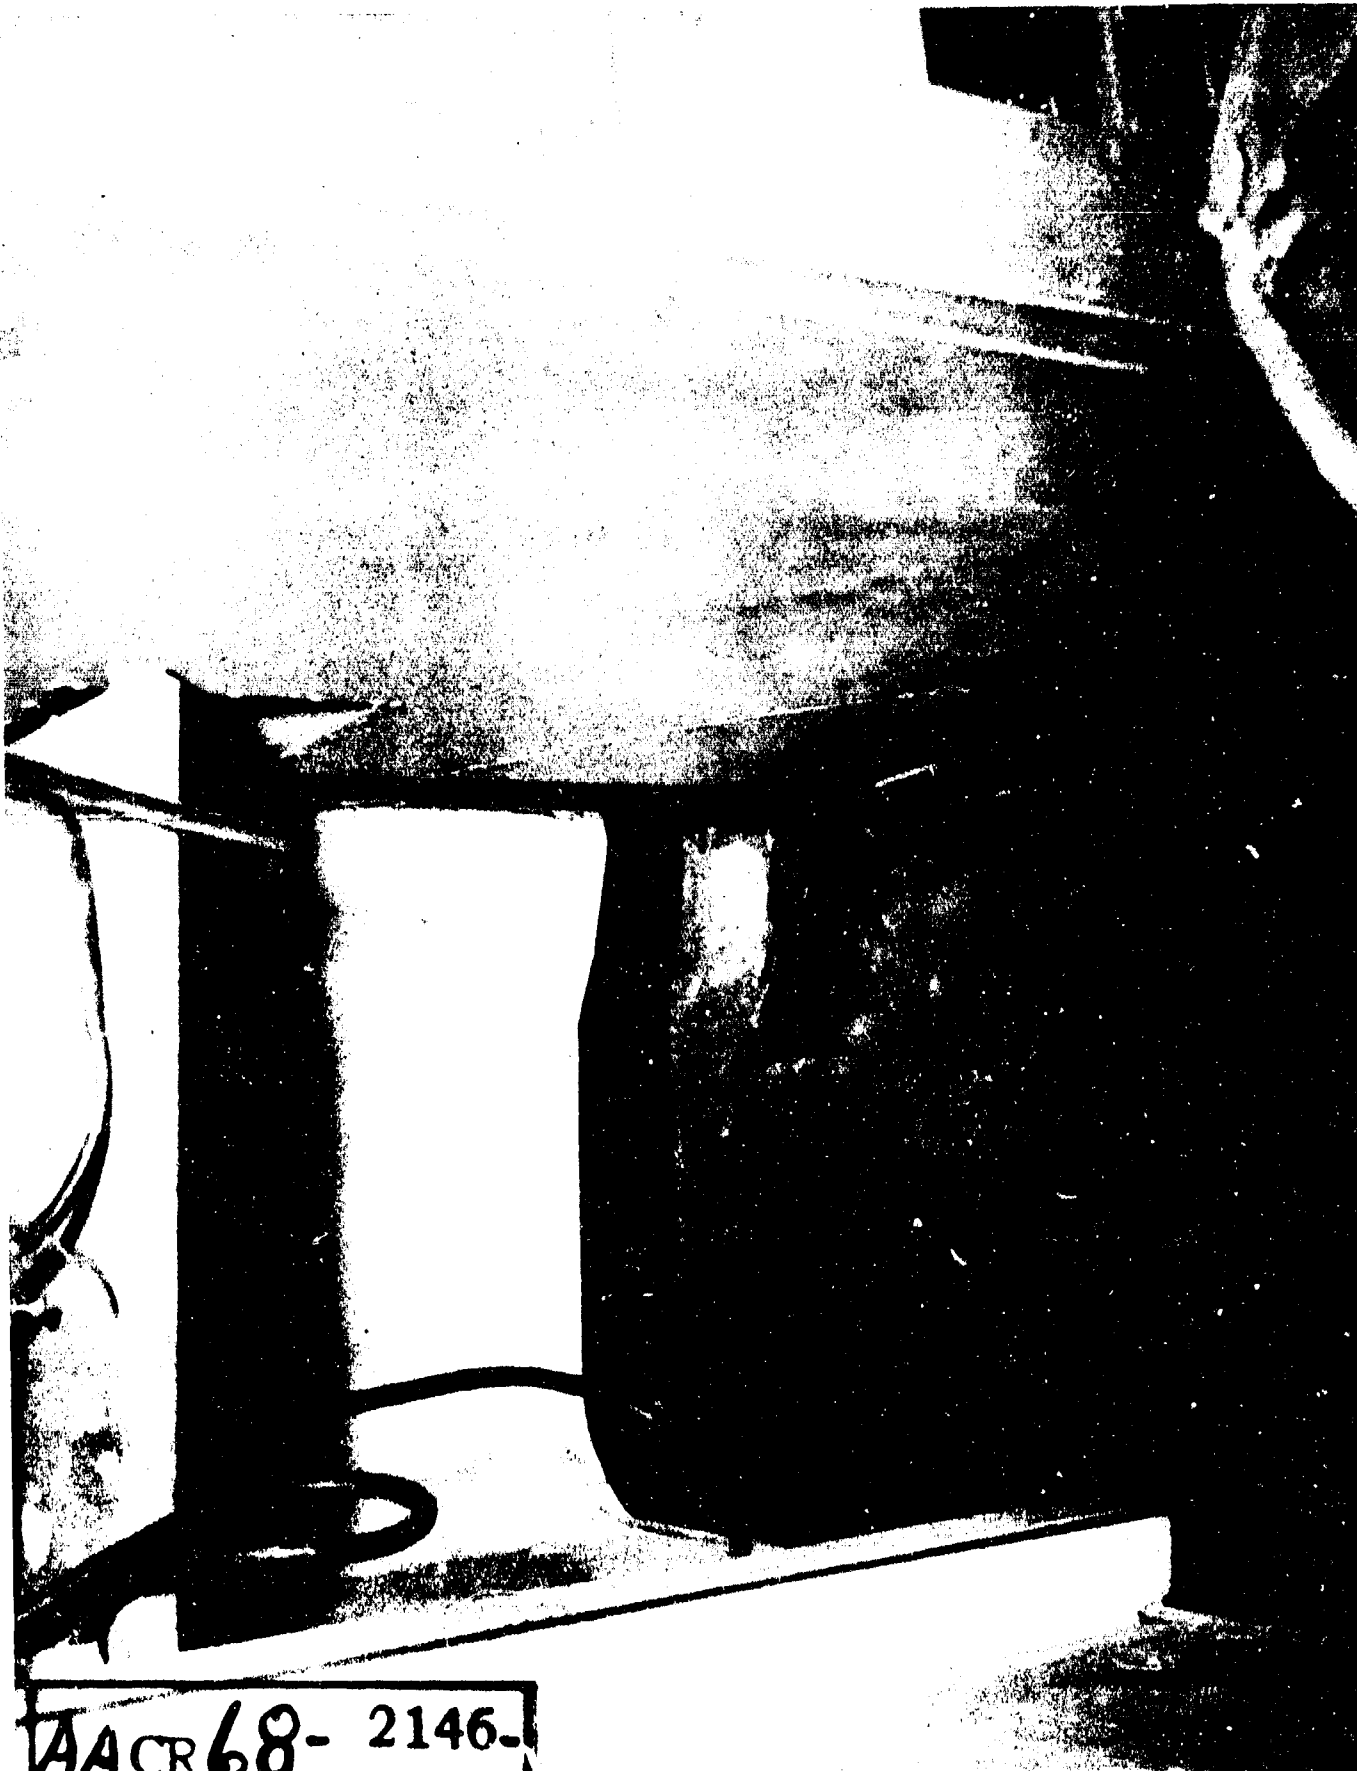
AA CR 68- 2146-1

AA-CR-68-2146-3. USS ARKANSAS (BB33). Aft starboard leg, wrinkle at 01 level.

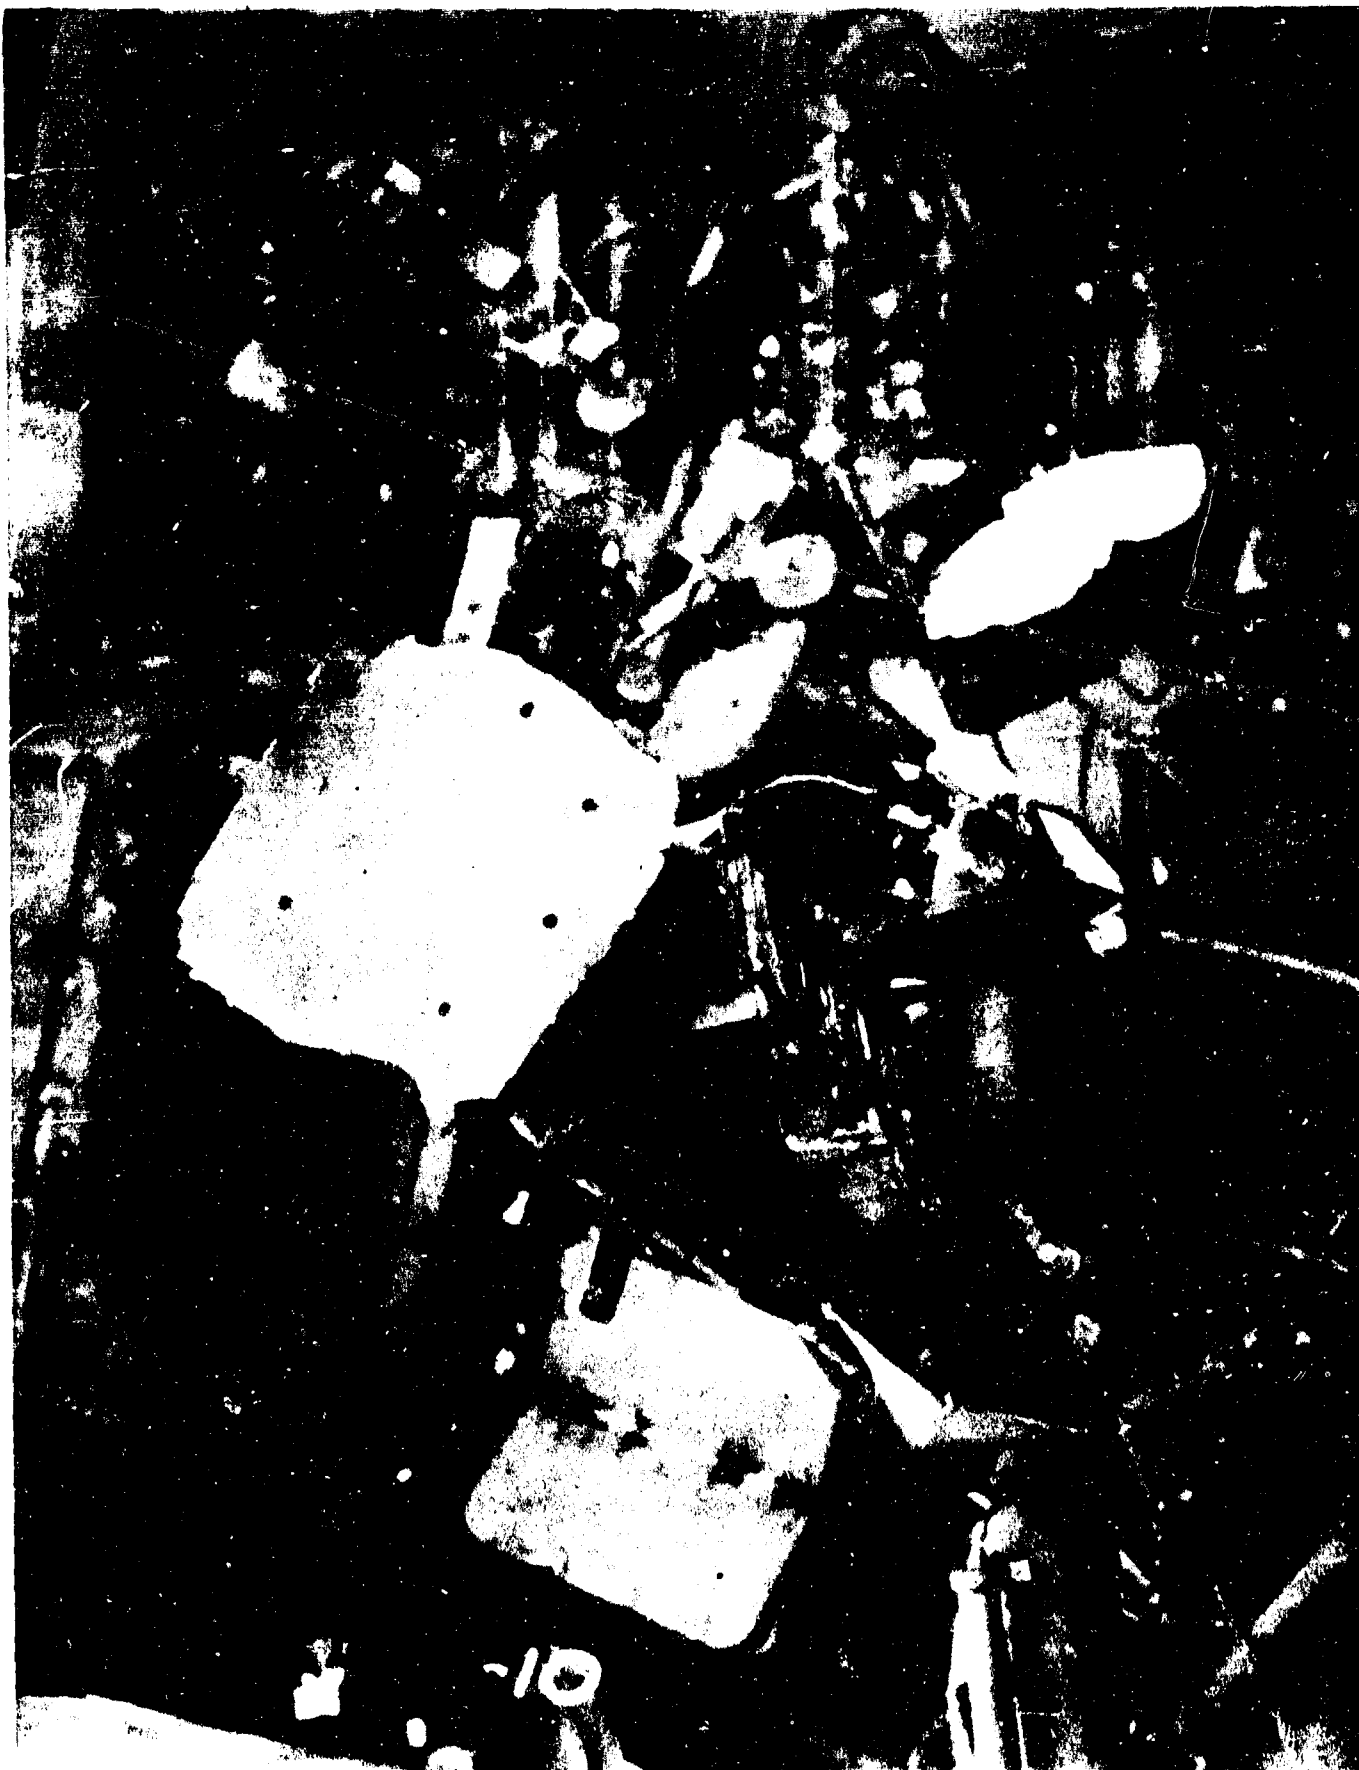
AA-CR-80-1895-10. USS ARKANSAS (BB33). Detail of base plate and yardarm brackets - mainmast.

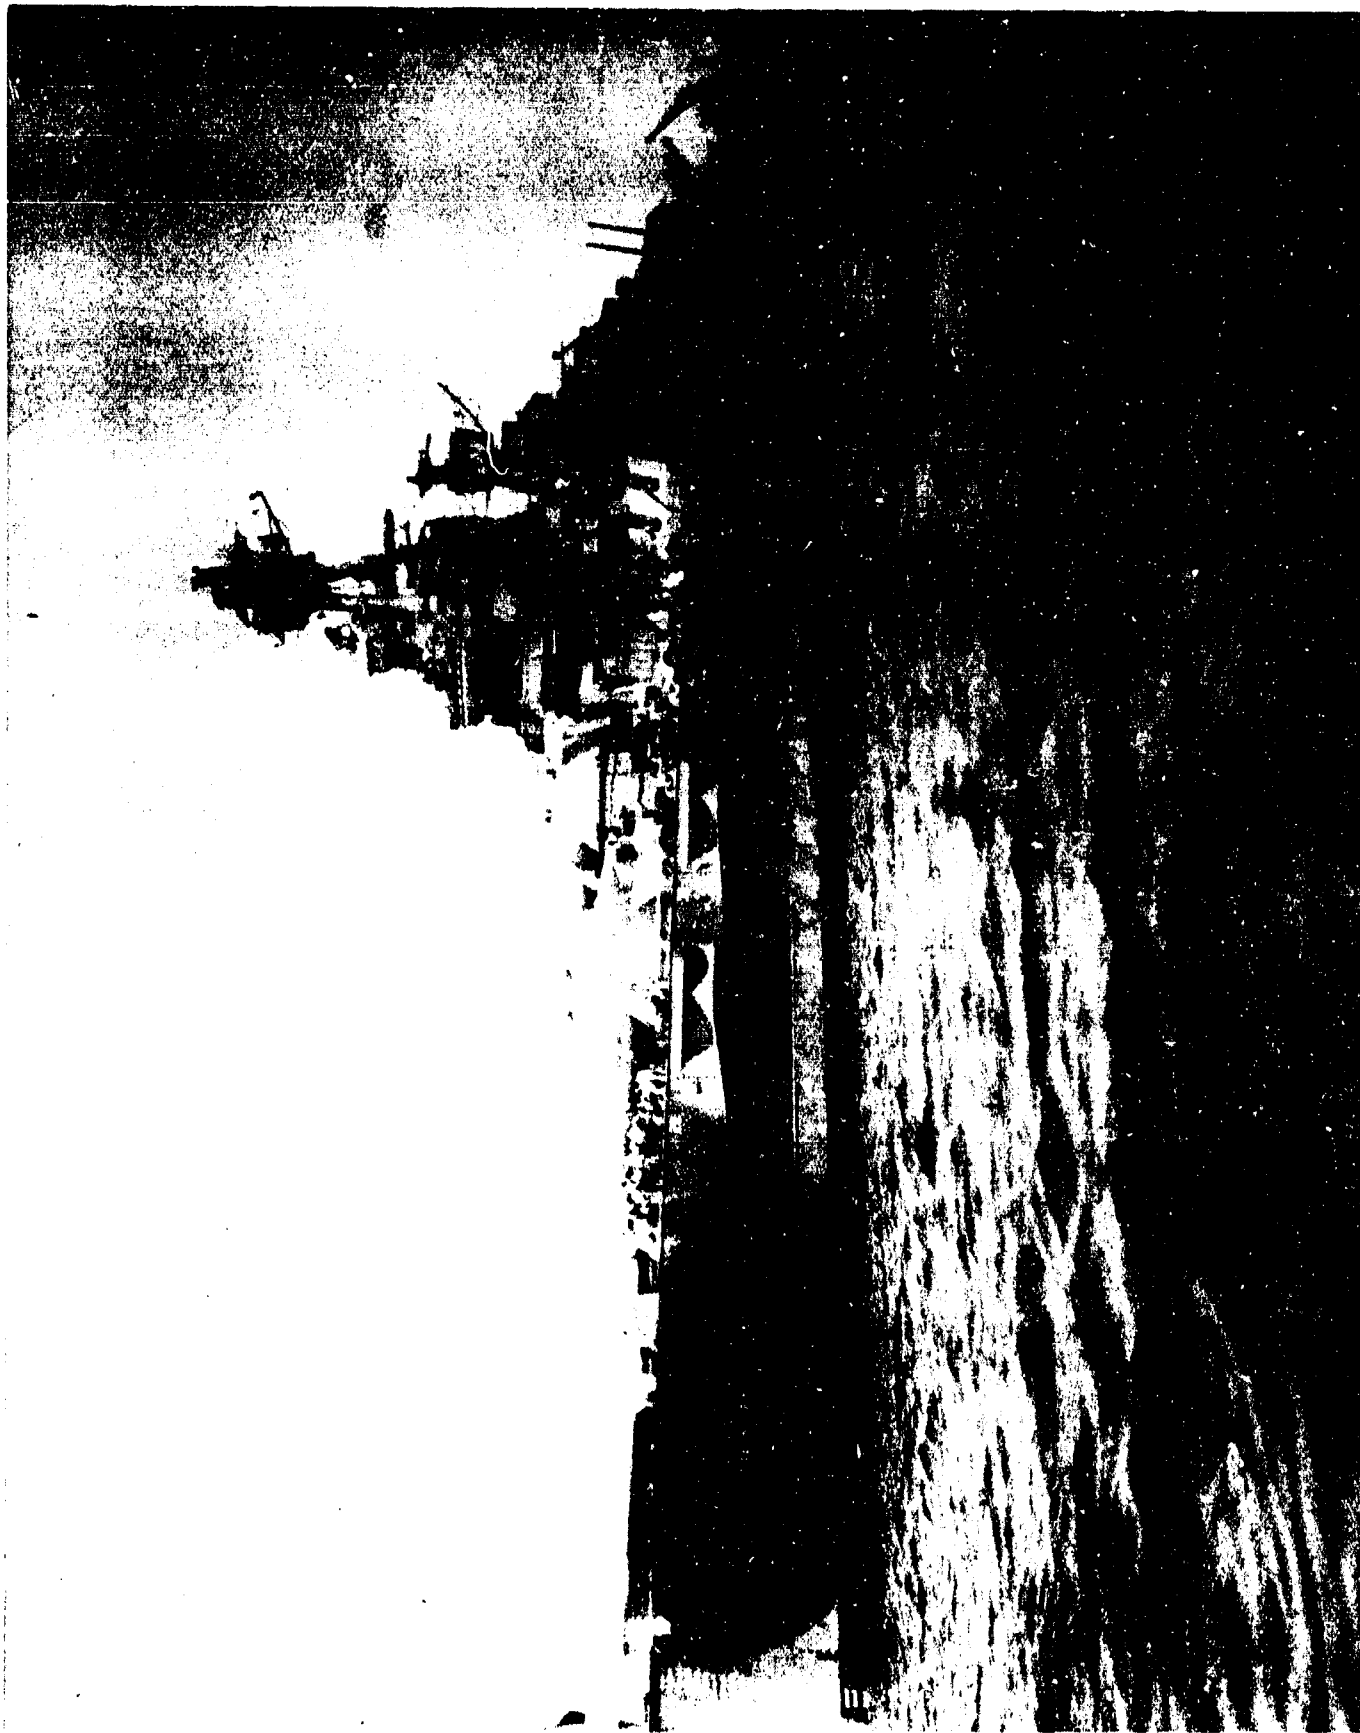
AA-CR-227-91-75. USS NEVADA (BB36). View looking at port bow after Test A.

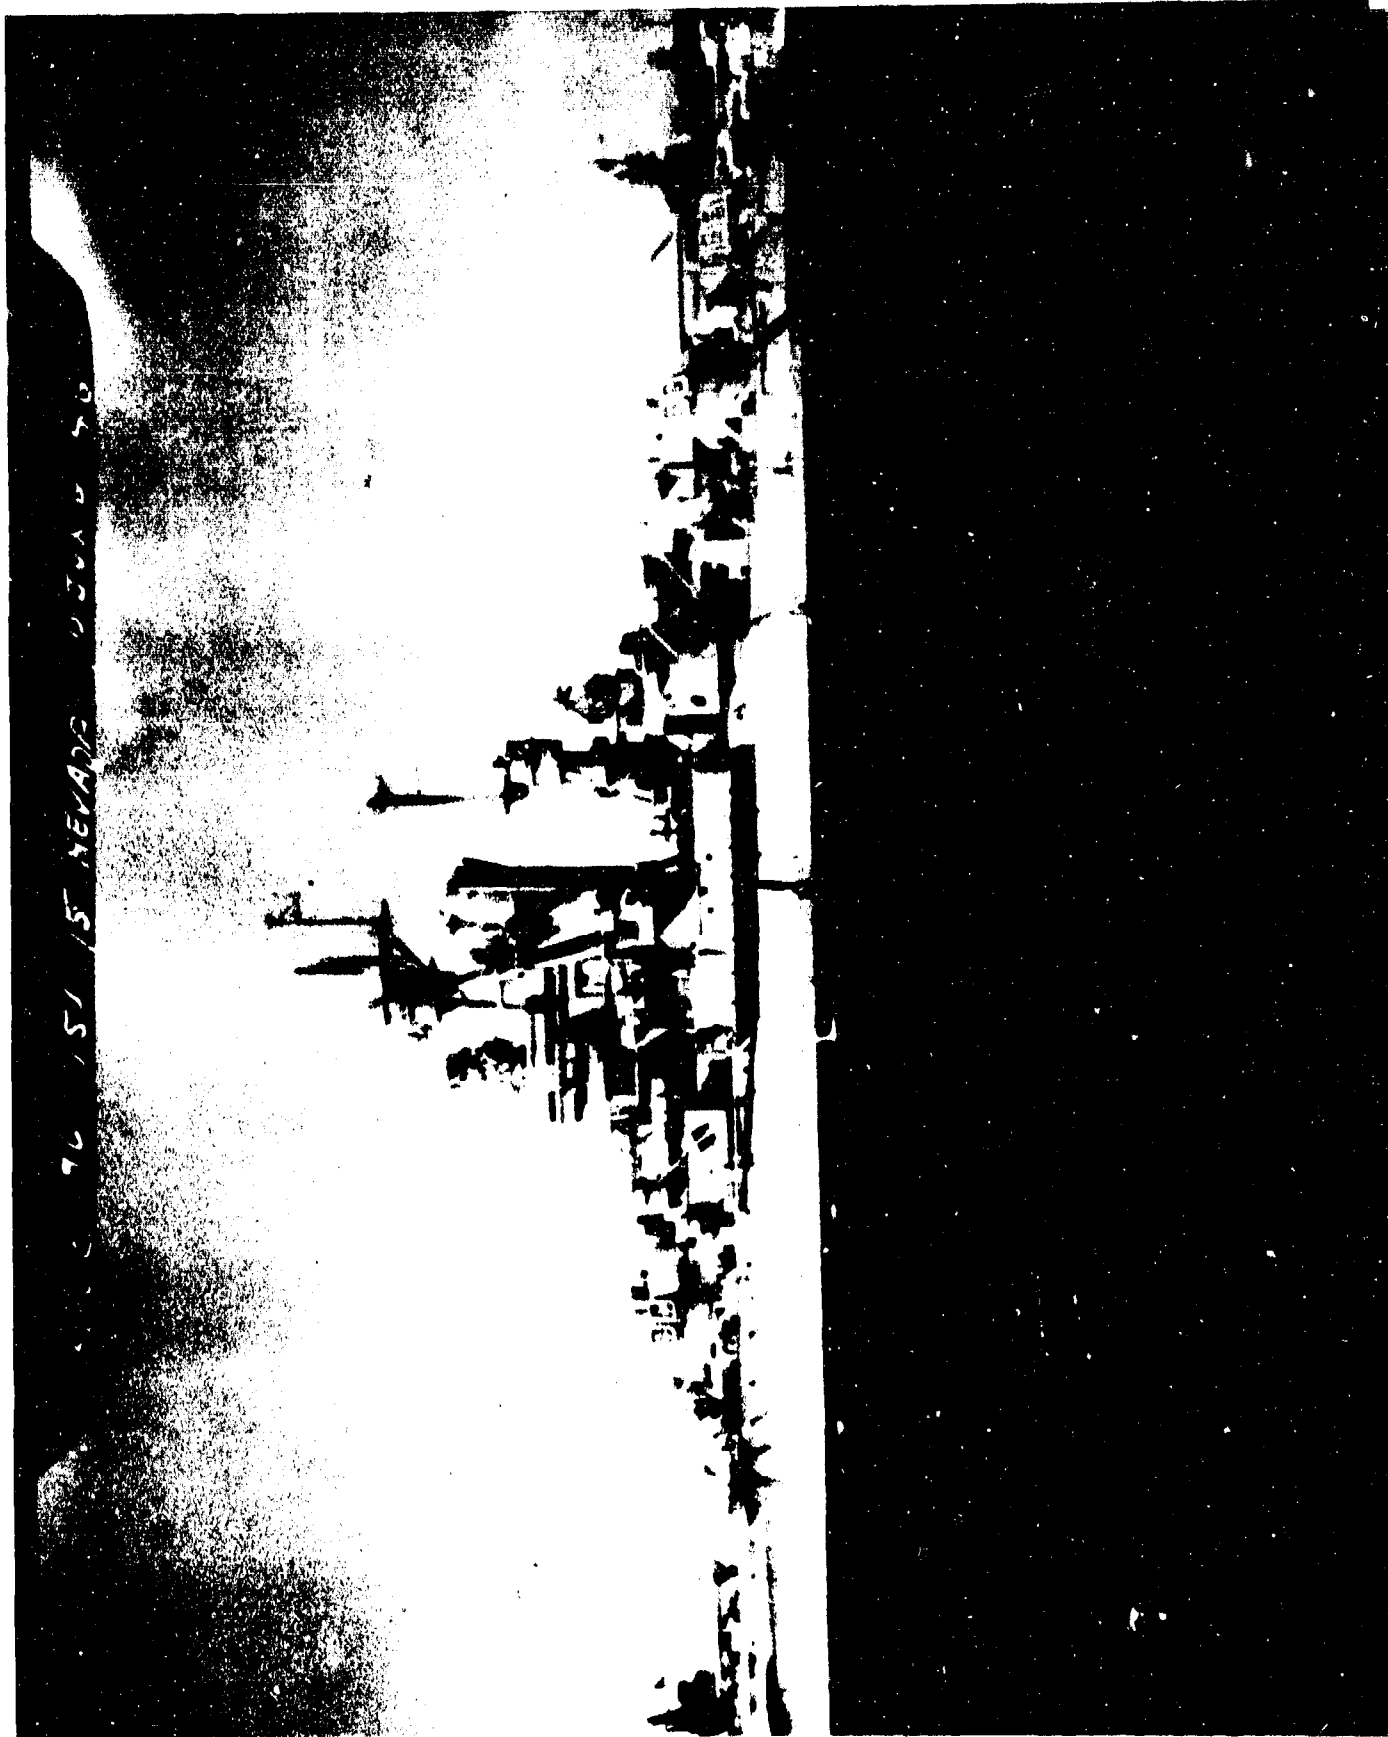
BA-CR-196-151-15. USS NEVADA (BB36). View of port beam before Test A.

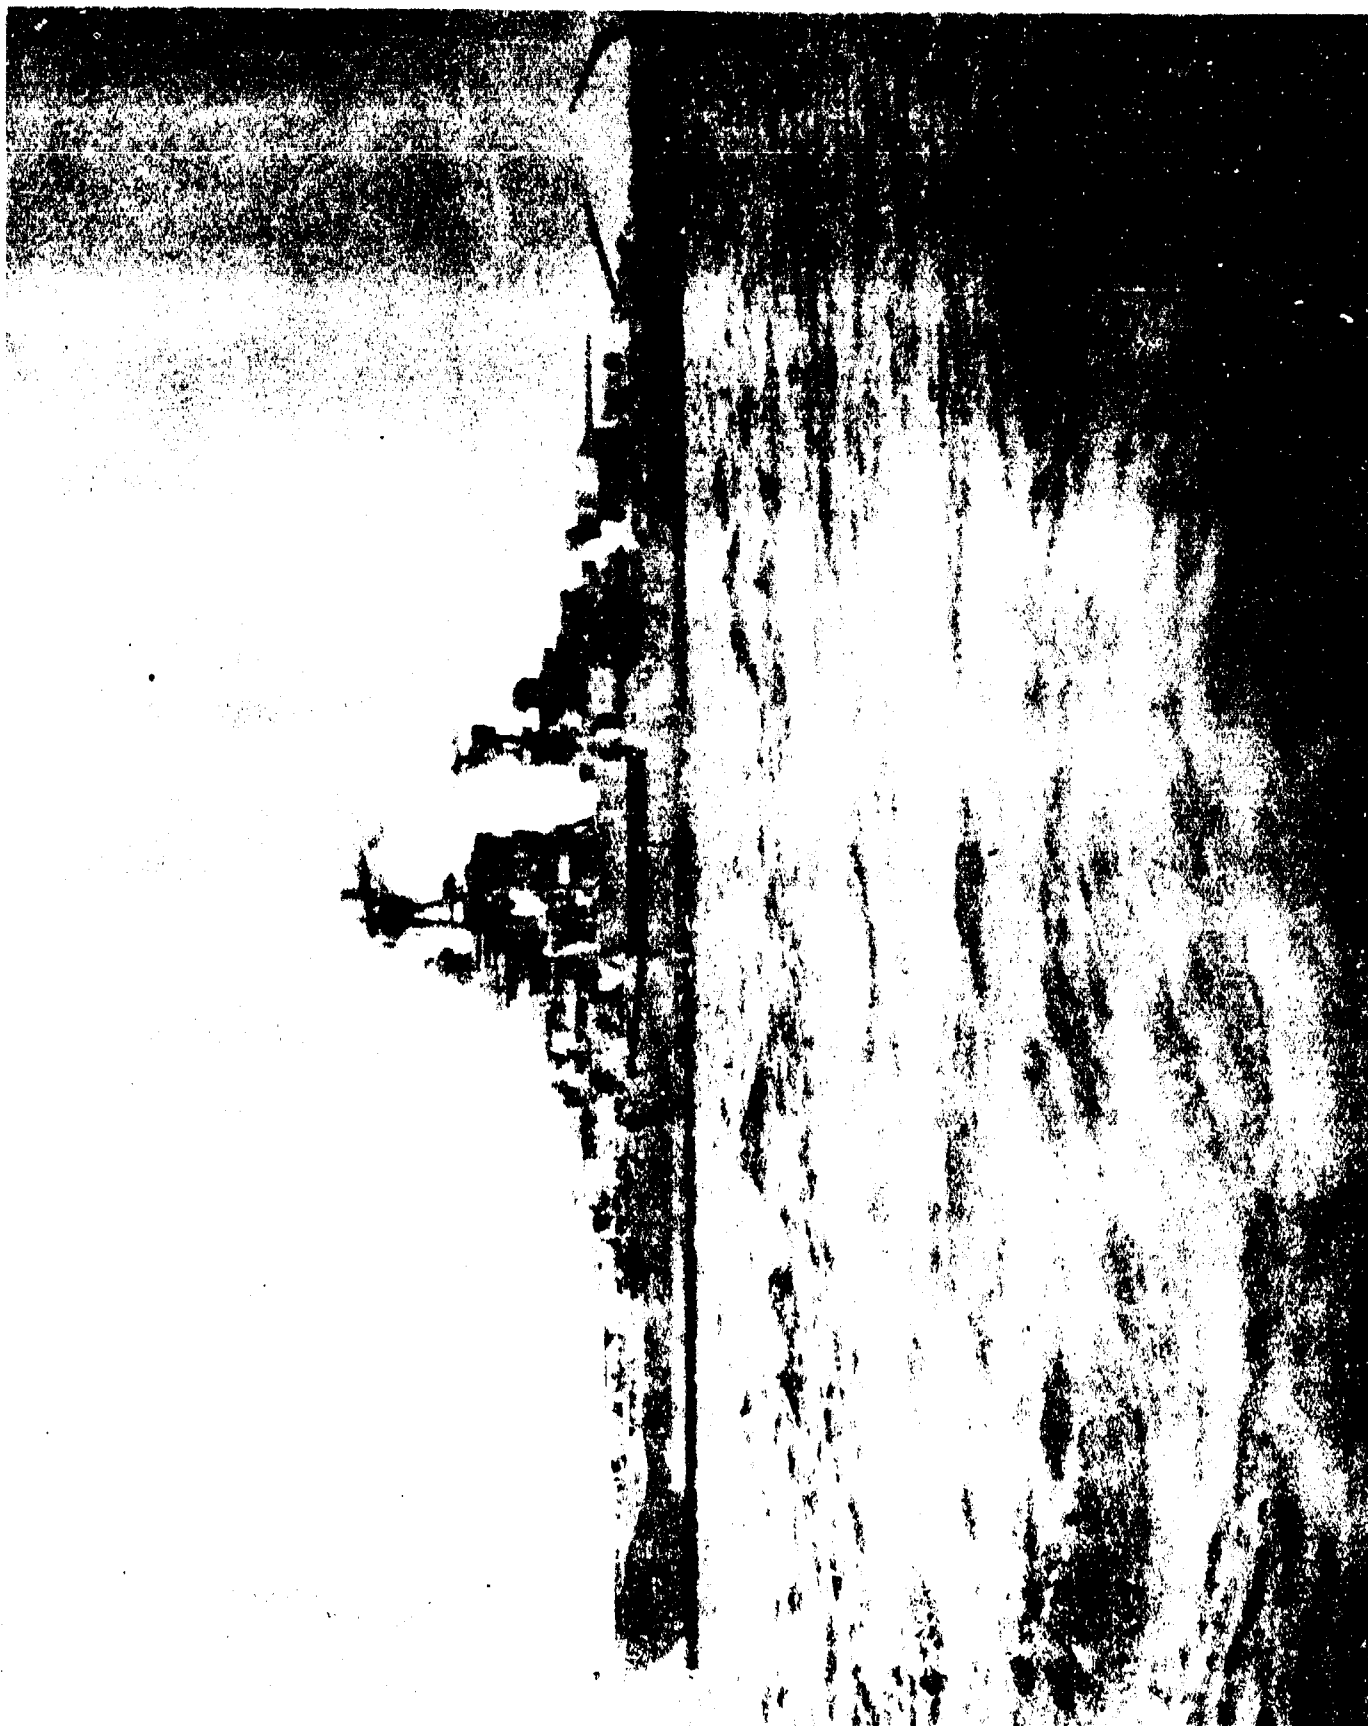
AA-CR-227-91-74. USS NEVADA (BB36). View of port beam after Test A

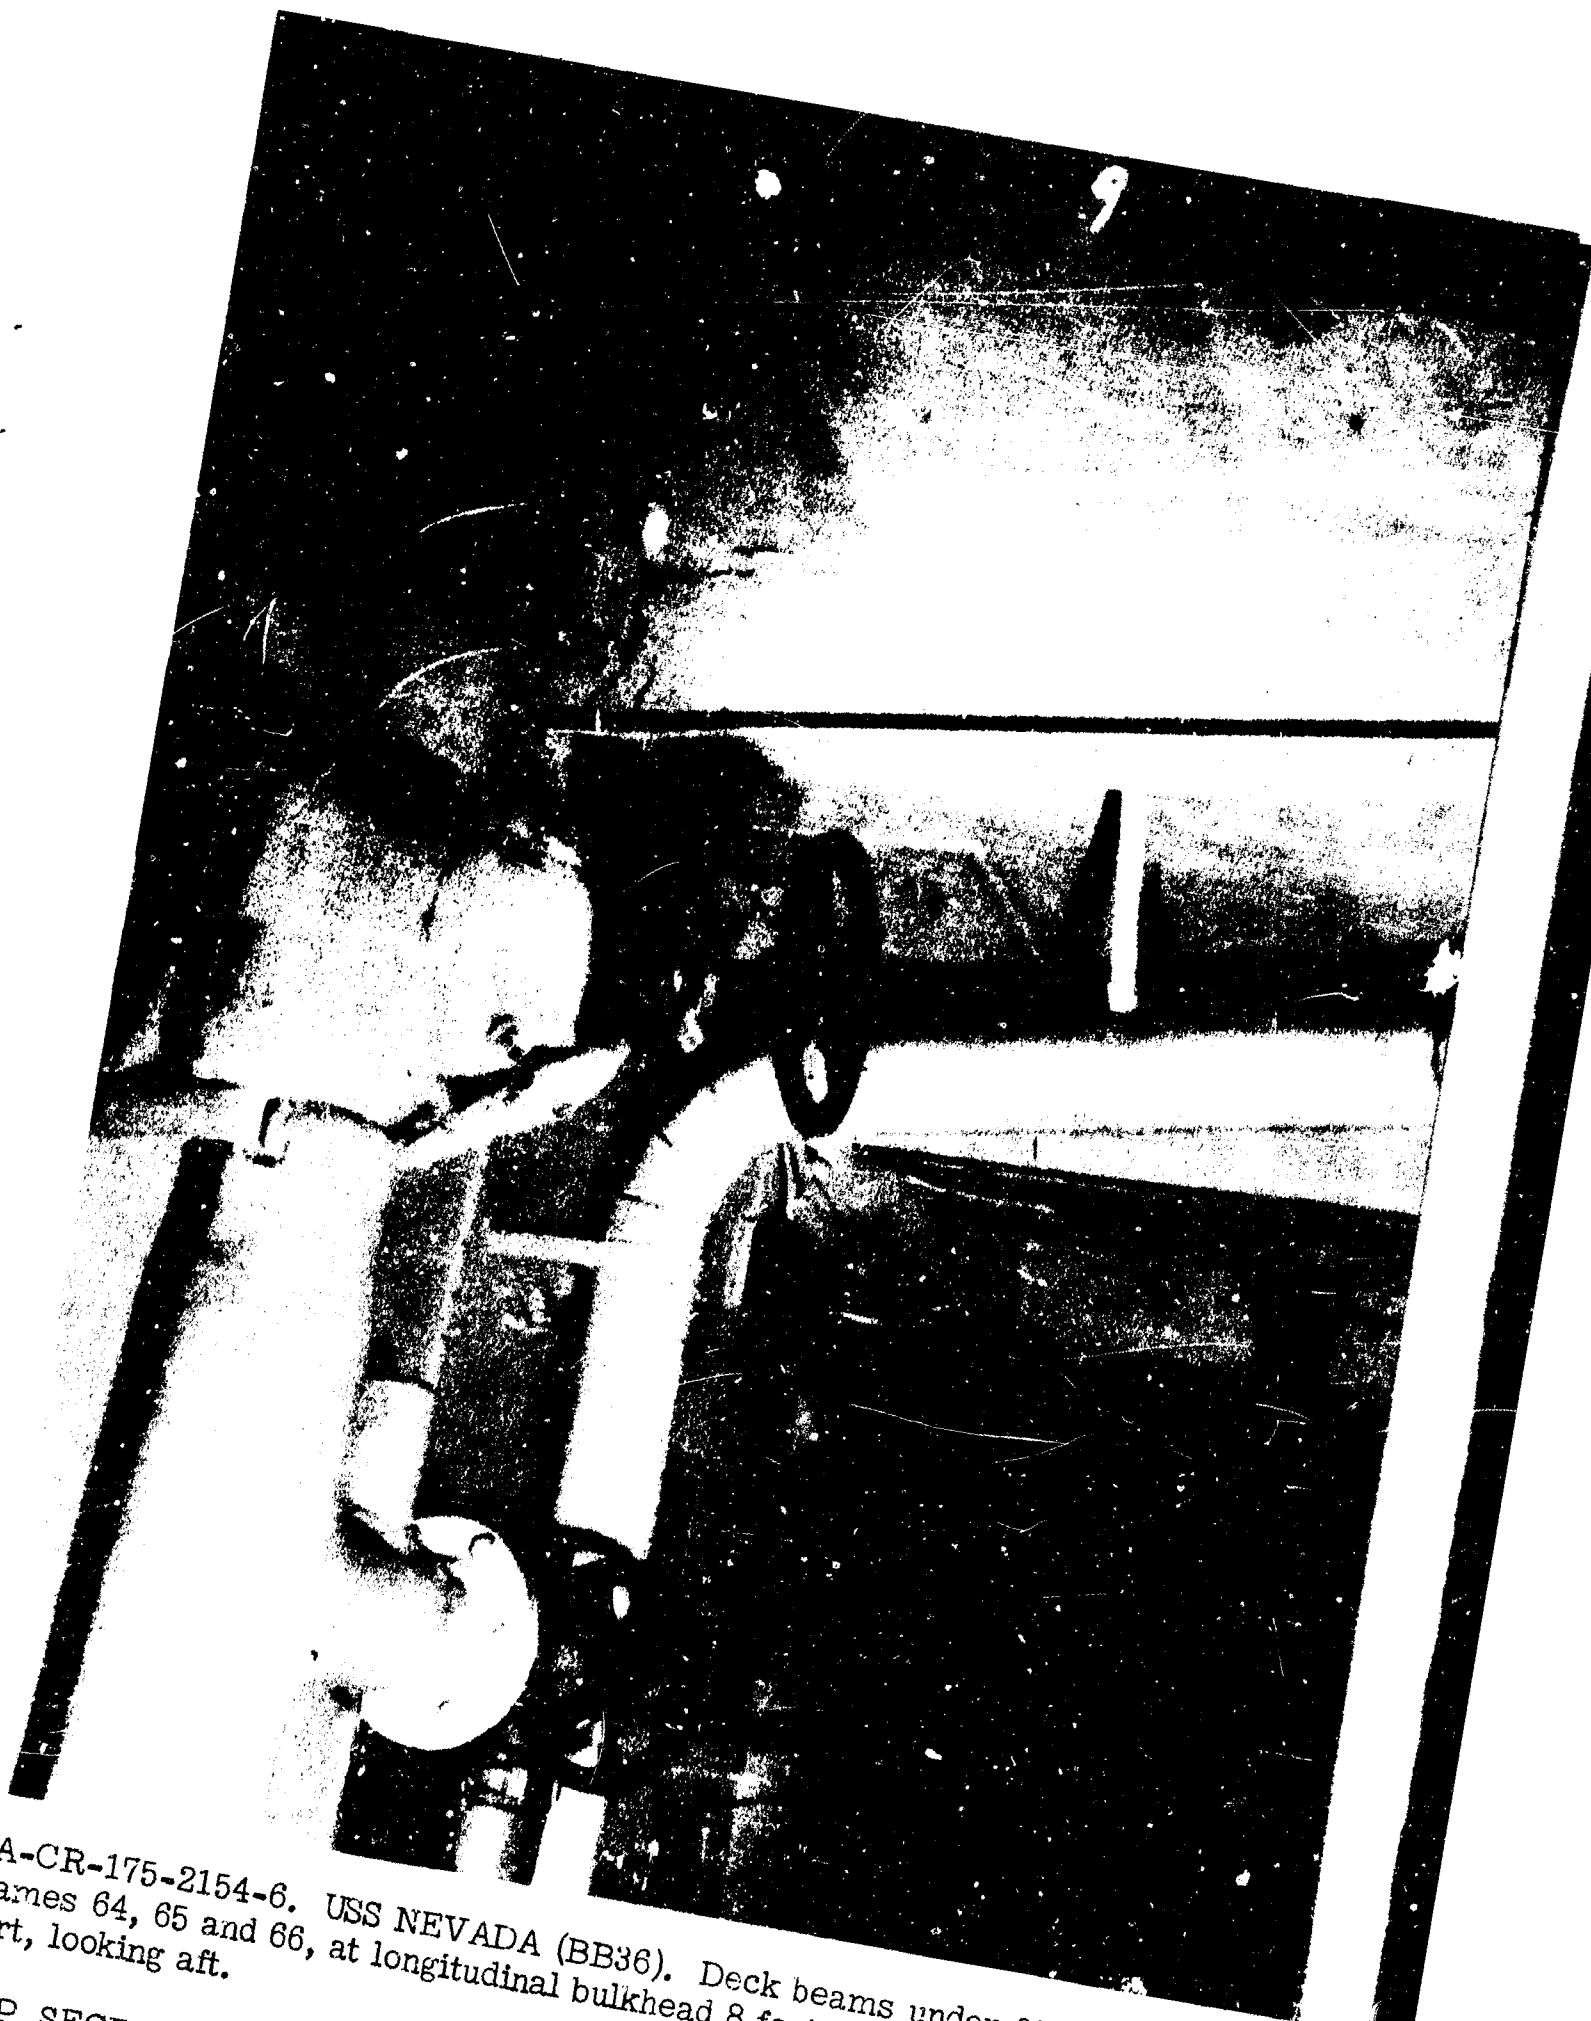
AA-CR-175-2154-6. USS NEVADA (BB36). Deck beams under 02 level frames 64, 65 and 66, at longitudinal bulkhead 8 feet off centerline to port, looking aft.

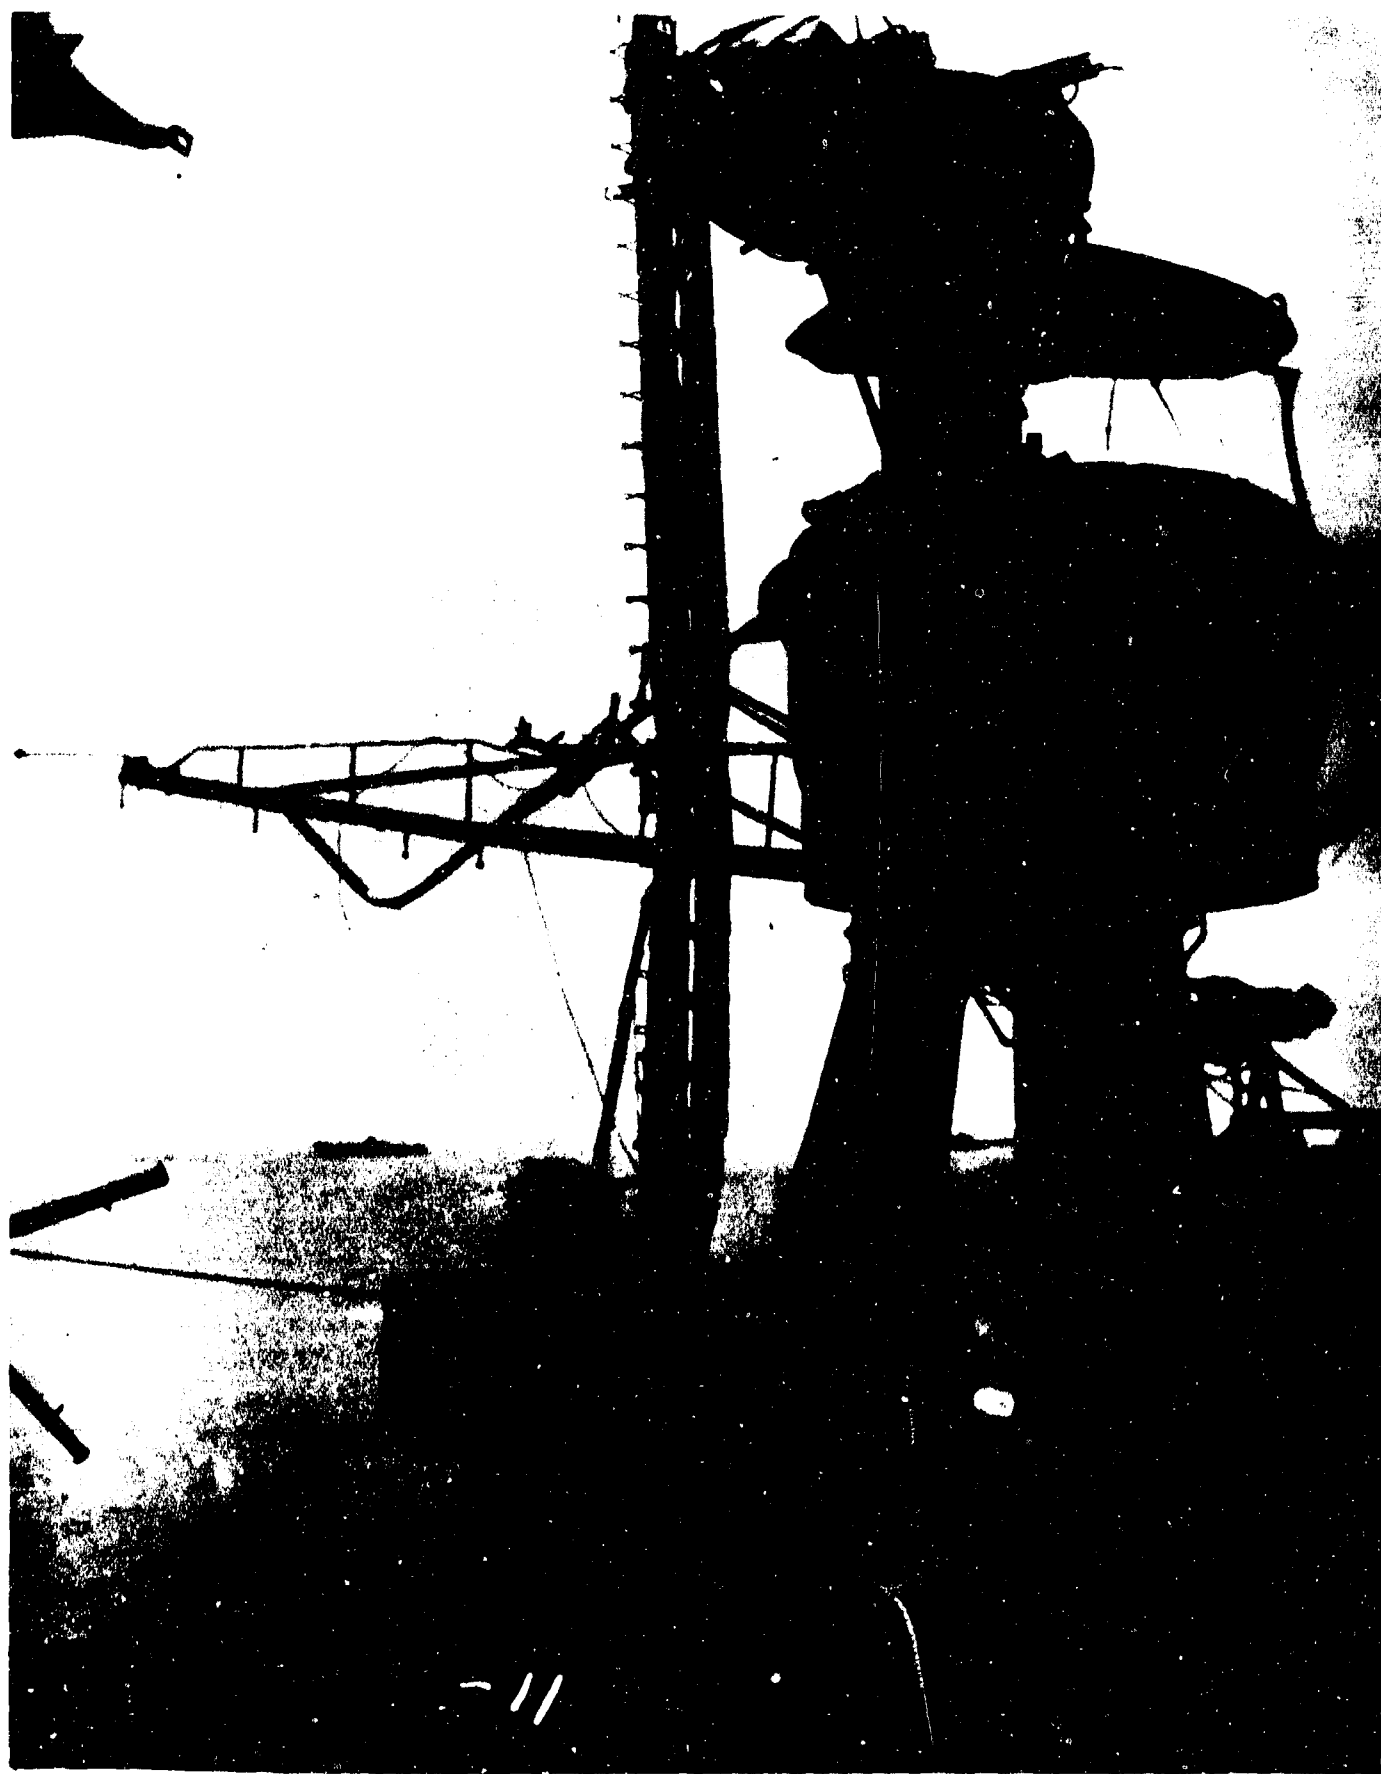
AA-CR-80-1897-11. USS NEVADA (BB-3). After tripod, looking aft and to starboard.
